## **CASE STUDY: DEBRIS SCREENED BUFFALO HEAD**

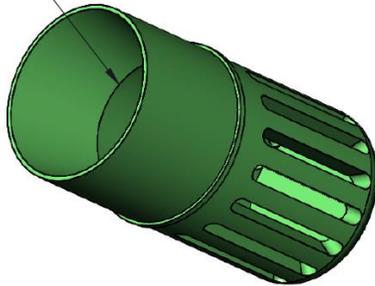
4.00" BORE  
AREA OF FLOW  
12.56 SQ INCHES

Fig 1: Patented 5 1/8" slotted debris screen

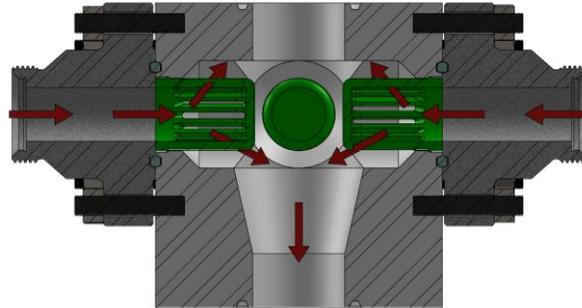
Fig 2: buffalo head with screened fracture ports

The primary function of IES's patented debris screens is to eliminate large debris and solids from entering the buffalo head bore and being pumped downhole. The risk of damage caused by debris and solids includes: premature screen out, stage loss, coil work resulting in significant added costs. In addition, packer balls are prevented from seating or partially seating causing erosion to the ball and seat area and eventual failure.

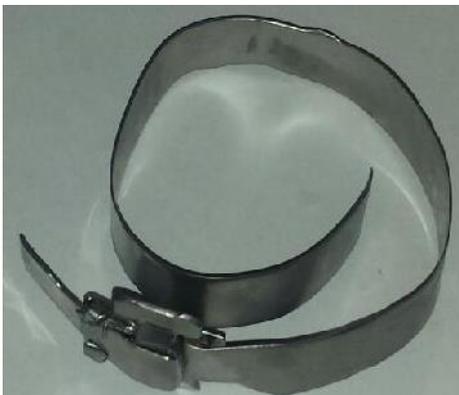
Fig 3: 4" Dia. pipe band

**Below are recent examples of actual debris caught in IES's screened buffalo head**

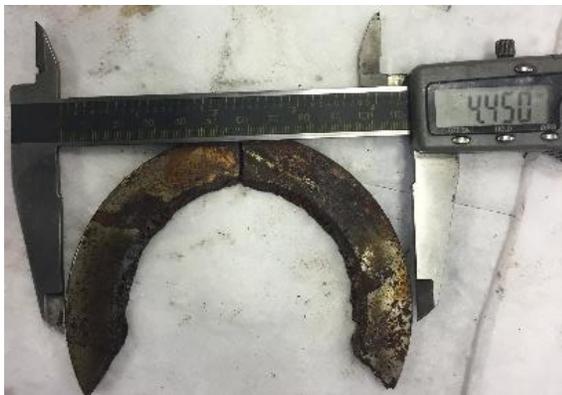
Fig 4: Frac pump seat

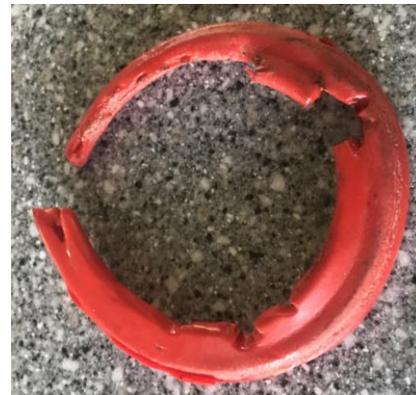
Fig 5: Pump Valve Seal (4.25")

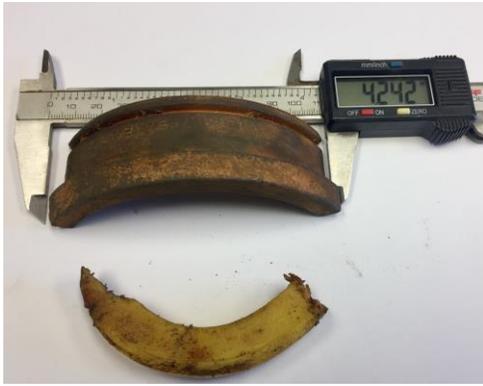
Fig 6: Weco Segment with Pump Seat

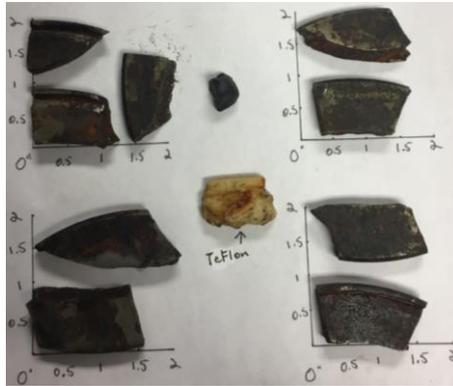
Fig 7: Suction valve & seat from pump

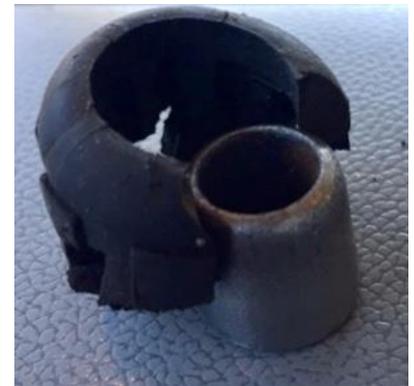
Fig 8: Pump Part with Elastomer

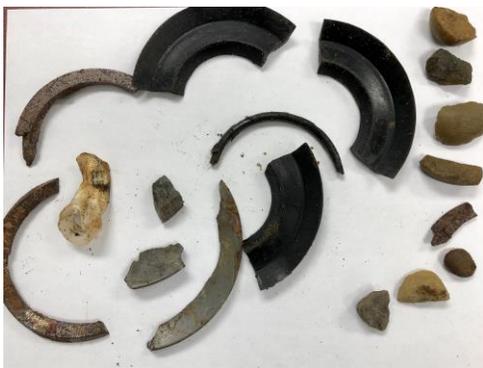
Fig 9: Metallic & Elastomer Valve Seal with Rocks

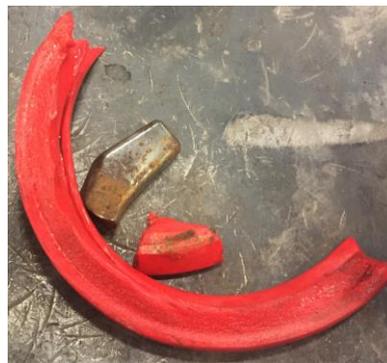
Fig 10: Pump Valve Seal and Steel Guide

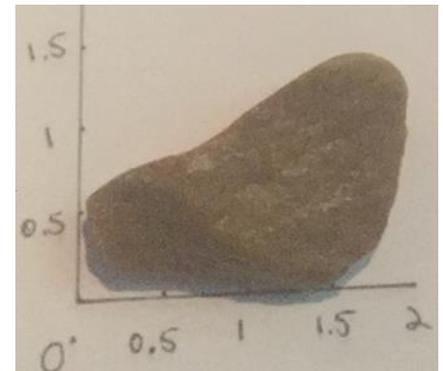
Fig 11: Large Stone

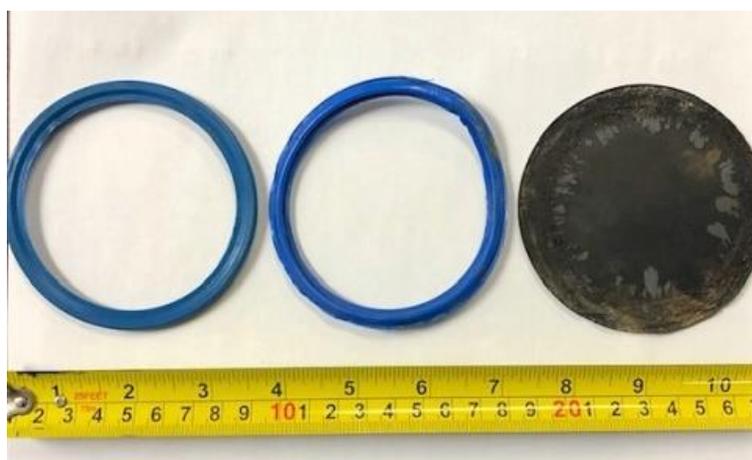
Fig 12: 3" Seal Debris
